Mark 20 Category II/III Instrument Landing System Operational Test and Evaluation, Functional and Performance Test Report

DOT/FAA/CT-TN95/44

Technical Report Documentation Page

16. Abstract This test report documents the results of the Operational Test and Evaluation (OT&E) Functional and Performance tests conducted on the Category II/III Mark 20 Instrument Landing System (ILS) at the FAA Technical Center, Atlantic City International Airport, Atlantic City, NJ. The Mark 20 ILS modular design is based on a new generation of microprocessors and software. With Remote Maintenance Monitoring (RMM) capability and the concept of "remove and replace" maintenance, it will provide major airway facilities throughout the U.S. with a more reliable and easily maintained system. The report contains the system configuration, test descriptions, test equipment used, data collection and analysis methods, test results, and conclusions. Based on testing performed at the FAA Technical Center, it is recommended that the Mark 20 ILS be accepted for deployment.

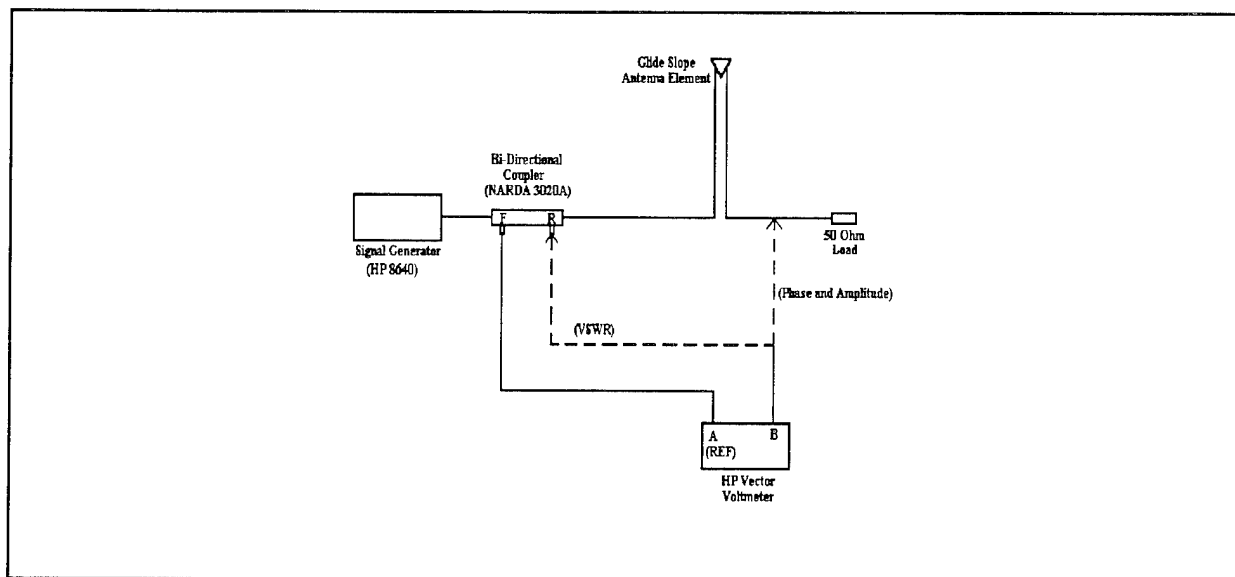
FIGURE 9. TEST CONFIGURATION FOR MEASURING VSWR, PHASE, AND AMPLITUDE OF GLIDE SLOPE ANTENNAS DURING ICE LOADING TESTING

Figure 9 shows the configuration for testing ice loading effects. Table 1 indicates the date, time, conditions, VSWR, phase, and magnitude of the measurements made on the antennas. This data indicates that no significant changes in measured parameters were observed during ice loading or antenna heater operation. The maximum variations from the baseline measurements were: VSWR: 0.03, Phase: 1.3°, and magnitude: 0.28 dB. Based on these measurements, it appears that the antenna heaters are not required. The data collected also indicates that antenna heater operation does not affect the radiated signal. During this testing period (8 months) no antenna heater failures occurred. Because the glide slope electronic equipment had not been delivered at the time of this test, these measurements were obtained using a signal generator for the provided signal, thus no signal in space measurements were possible and no determination of actual provided guidance can be made.
